# Don't Stop THE PRESSES

A pulp & paper mill needed to rebuild or replace its RTO, but shutting down the system was not an option.

By **KEVIN NESBITT**, National Sales Manager for Nestec Inc.

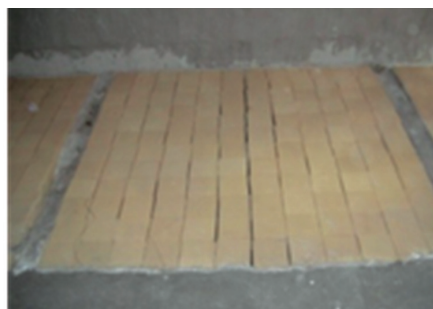
**The old ceramic media had broken down and needed removal.**

They also recommended removal of the existing media and fabrication of new heat

recovery baskets and adding new media. This would be followed by installing insulation on the lower section externally and internally. The mill would provide the labor, equipment and materials to build a sloped floor in the outlet of the oxidizer. The design, fabrication and installation of a new rotor wash system would be provided by the RTO manufacturer.

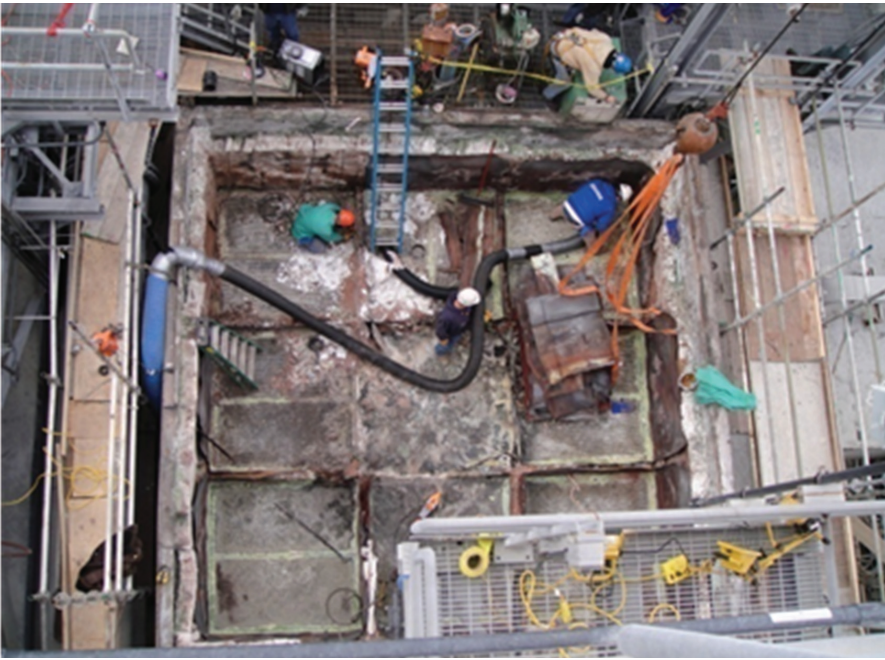
**The old ceramic media is removed from the heat-recovery baskets.**

ered damage would now require new materials. Another challenge was that the eight hours that were initially estimated to remove media were inadequate. However excellent contractors and clear communication with mill management meant these initial issues were quickly and successfully addressed.

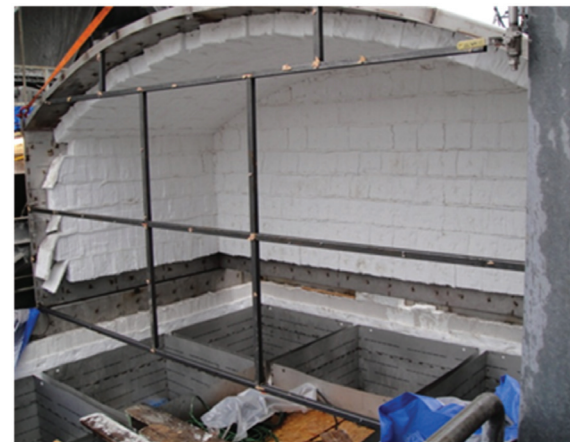
**The heat-recovery baskets were rebuilt and reloaded with new media.**

After removal of the eight heat recovery baskets, new heat recovery baskets, fabricated from 16-gauge, 253-MA alloy steel, were installed. The baskets were filled with ceramic heat recovery media consisting of a combination system of 25-cell monolith ceramic block regenerative heat recovery media stacked 4 feet high, followed by 1 foot of 32-cell monolith ceramic block regenerative heat recovery media.

The installed media was specified to be chemically and thermally stable for rapid heat up and cool down of the system. The media would greatly reduce the previous pressure drop, as well as reduce the resultant stresses on the combustion chamber, valves and fans. Due to its cell sizes, the media was much more tolerant to particulates. The media change had the positive effect of reducing the pressure drop by approximately 10 inches wc. The top 12 inches of media, which would be subjected to temperatures above 1,100°F,

consisted of Ceram CR20 ceramic block. CR20 provides alkali resistance and possesses a proven reliability record in this process environment. The lower levels used Ceram NT ceramic block, which also provided alkali resistance at lower temperatures.
